Exhaust System Adjustment Guide
3" Turbo-Back & Cat-Back Exhaust Systems
2010 Volkswagen GTI MK.VI
Dual Rear Exit w/ Single 4.0" Tips / Side
FE100037 & CB100047

System Adjustment Guide for Installation of the APR MK VI GTI Turbo-Back & Cat-Back Exhaust Systems:

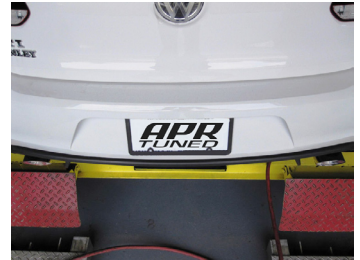
Fig. A

A misalignment condition may be observed after the initial installation of the APR cat-back or turbo-back exhaust system for the Mark VI GTI. If the system is not adjusted properly, the right side exhaust tip may protrude excessively far out from the rear valence, and more of this tip will be exposed when compared to the left side exhaust tip. (See Fig. A)

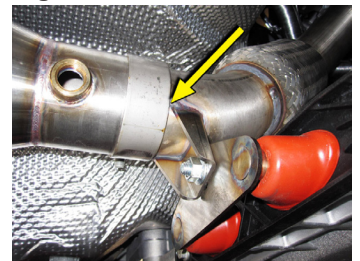
Fig. B

A) For the turbo-back system, the catted midpipe section should be slid onto the upper downpipe section until the edge of the expansion is just short of touching the hanger mounting bracket. (See Fig. B)

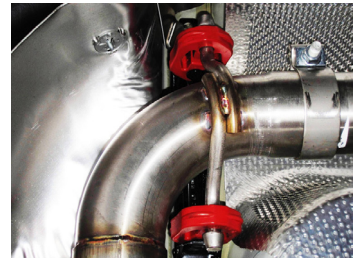
Fig. C

Next, verify that both of the front tunnel muffler hangers, and the rear tunnel muffler hanger, are swung noticeably forward in the corresponding mounting grommets on the vehicle. (See Fig. C, D, & E) The front hanger grommet on the inside of the bend, as shown in figure D, should almost be touching the heat shielding material.

B) For the cat-back system, make sure that the end of the stock downpipe is trimmed enough to allow for the tunnel muffler hangers to be properly positioned according to figures C through E. If this positioning cannot be achieved, then additional length should be taken out of the end of the stock downpipe.

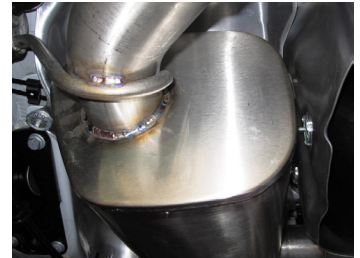
Fig. F

Also, check that the tunnel muffler has proper clearance on both sides within the vehicle cavity. **(See Fig. F)** The flexibility of the upper sections of both the APR and the stock downpipes should allow for the tunnel muffler to be moved side-to-side as needed.

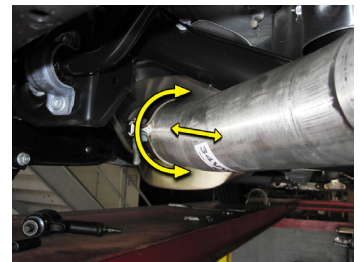
Fig. G

The rear axle pipe section can be moved by adjusting the amount of overlap at the inlet expansion, and by rotating the rear axle pipe section about the expansion joint. **(See Fig. G)**

Next, the axle pipe rotation should be set so that the middle of the pipe before the "U" bend is parallel to the ground. **(See Fig. H)** The weight of the rear muffler will try to rotate the axle pipe counter-clockwise about the joint shown in figure G, and make the middle of the pipe slope down at an angle **(See Fig. I)**, which will result in everything else being improperly positioned. The rear muffler will likely need to be pushed upwards on the left side while pulling down on the rear axle pipe near the hanger on the right side in order to rotate this pipe clockwise about its inlet and into the proper position.

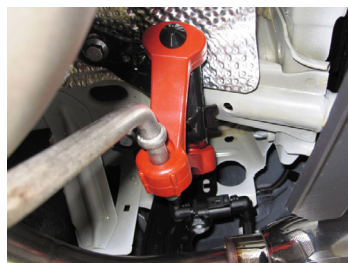
Fig. K (Incorrect)

The right side rear hanger should be double checked at this time to be swung well forward in the corresponding mounting grommet on the vehicle. **(See Fig. J)** If it is only swung slightly forward in the grommet, then the axle pipe is not positioned correctly, **(See Fig. K)** and additional adjustments should be made according to the above steps until it is properly positioned.

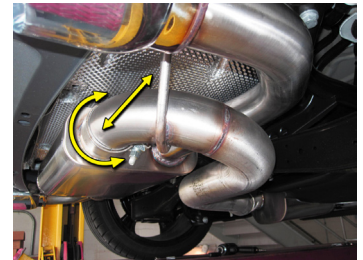
Fig. L

The rear muffler section can be moved by adjusting the amount of overlap at the inlet expansion, and by rotating the rear muffler section about the expansion joint. **(See Fig. L)**

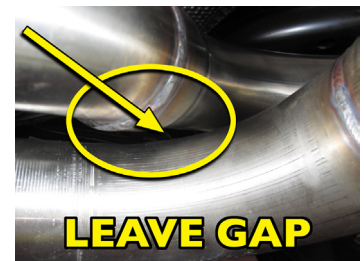
Fig. M (Correct)

Next, the rear muffler rotation should be set so that there is adequate clearance (approx. a finger tip sized gap) between the tip pipe and the axle pipe. **(See Fig. M)** If the front of the rear muffler is rotated too far downwards, and the right side exhaust tip is too far upwards in the rear valence, then the tip pipe and the axle pipe may be contacting each other at this point **(See Fig. N)**, which will result in a potential rattling sound being made while the vehicle is running.

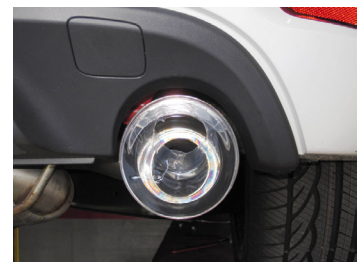
Fig. O

When the overlap and rotation of the rear muffler are both correctly adjusted, the tip will be properly positioned in the rear valence. **(See Fig. O)** If the right side tip sits too low when there is the proper amount of clearance between the tip pipe and the axle pipe, then the rear axle pipe **has not been rotated sufficiently clockwise at its inlet** and should be readjusted according to step two above.

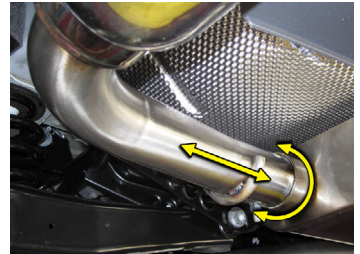
Fig. R

The left side tip pipe section can be moved by adjusting the amount of overlap at the inlet expansion, and by rotating the left side tip pipe section about the expansion joint. (See Fig. R)

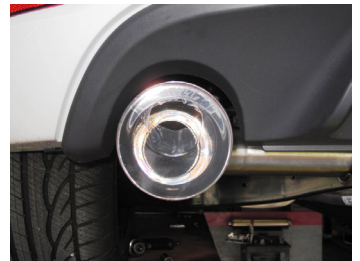
Fig. S

Next, the left side tip pipe rotation should be set so that the vertical gap between the left side exhaust tip and the rear valence is the same as it is for the right side exhaust tip positioned in step 3 above. When the overlap and rotation of the left side tip pipe are both correctly adjusted, the tip will be properly positioned in the rear valence. (See Fig. S)

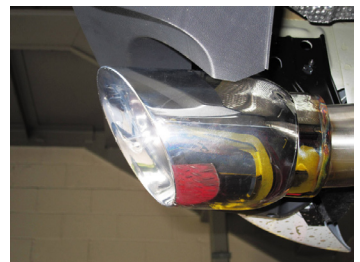
Fig. T

Finally, the left side exhaust tip depth should be double checked at this time; the outer top edge of the tip should align with the edge of the rear valence when viewed from the inside as shown. (See Fig. T) Verify that the left side rear hanger is swung well forward in the corresponding mounting grommet on the vehicle as shown. (See Fig. U) The tip depth relative to the rear valence should now be equal between both the left and right side exhaust tips. (See Fig. P & T)

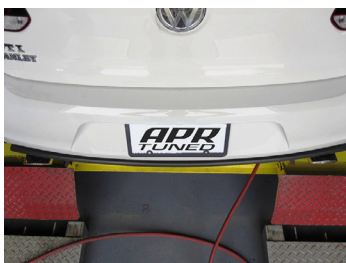
Proper adjustment of the APR Mark VI GTI cat-back or turbo-back system can be achieved by following the above steps of this adjustment guide in the proper sequence. Both exhaust tips should now look even and symmetric to each other in both the up and down and front to back directions, and should both be centered in the tip cutouts in the rear valence as shown. (See Fig. V & W)
